# Proposed High-Voltage High-Current Solid State Tesla Coil Spark Gap Design

Terry Fritz

May 3, 2006  
First Testing

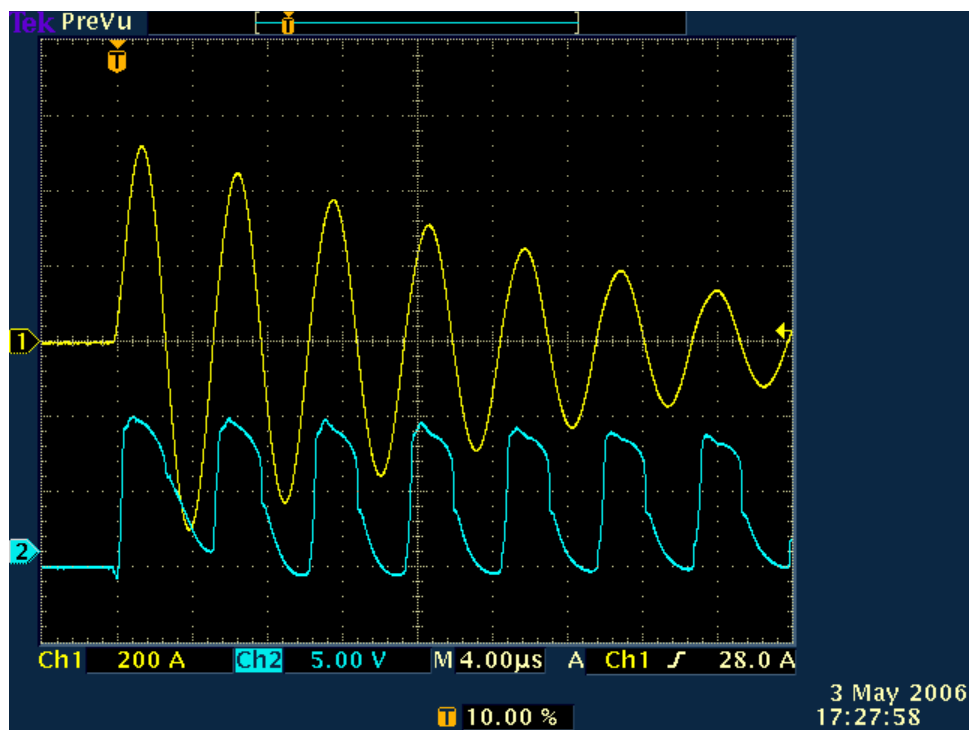
4  $\mu$ S/div Current (yellow) 200A/div Gate Voltage (blue) 5V/div

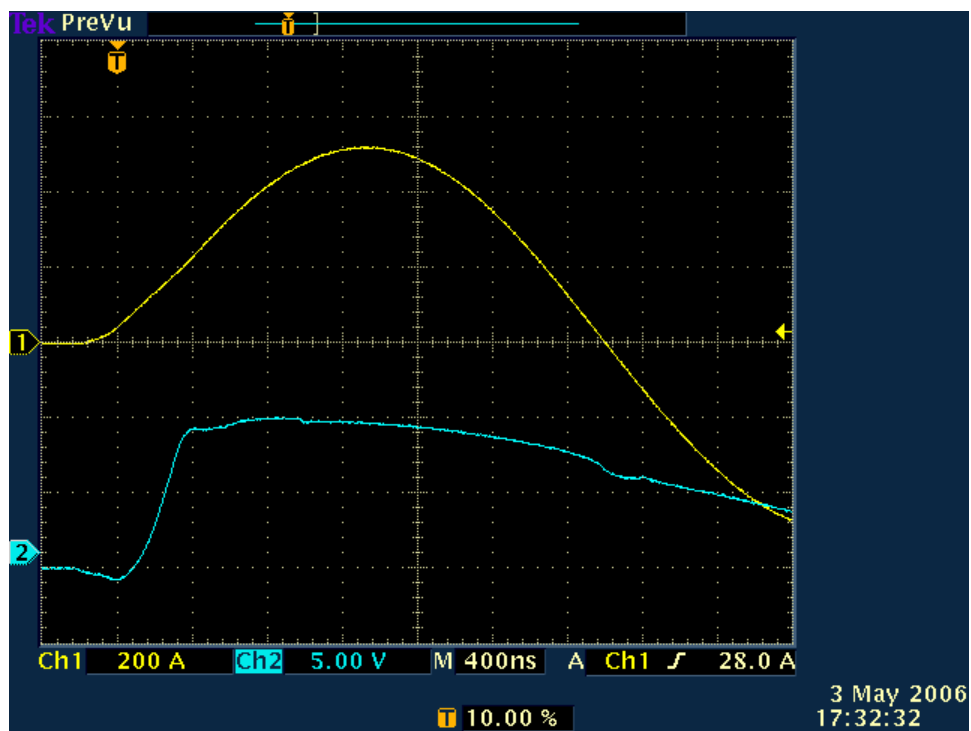
400nS/div Current (yellow) 200A/div Gate Voltage (blue) 5V/div

The gate voltage is not reaching the expected 24V. It appears to reach about 10 volts where the IGBT is expected to be turned on and able to pass about 150 amps. From the second scope capture, it appears the IGBT is turning on and removing charge voltage from the gate circuit so it can no longer continue charging to the proper voltage.

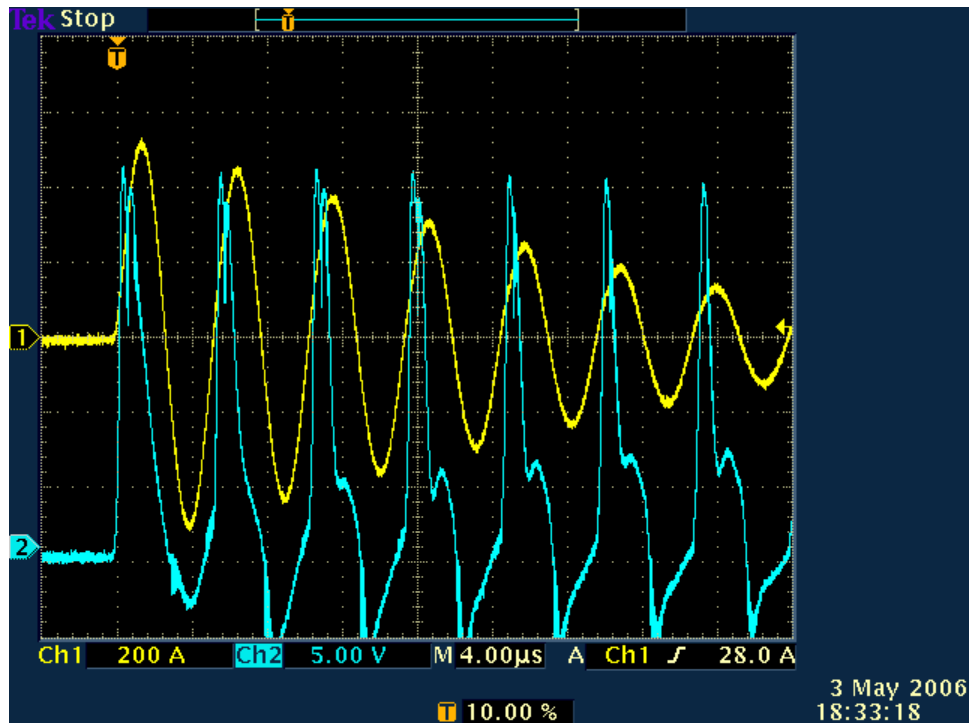
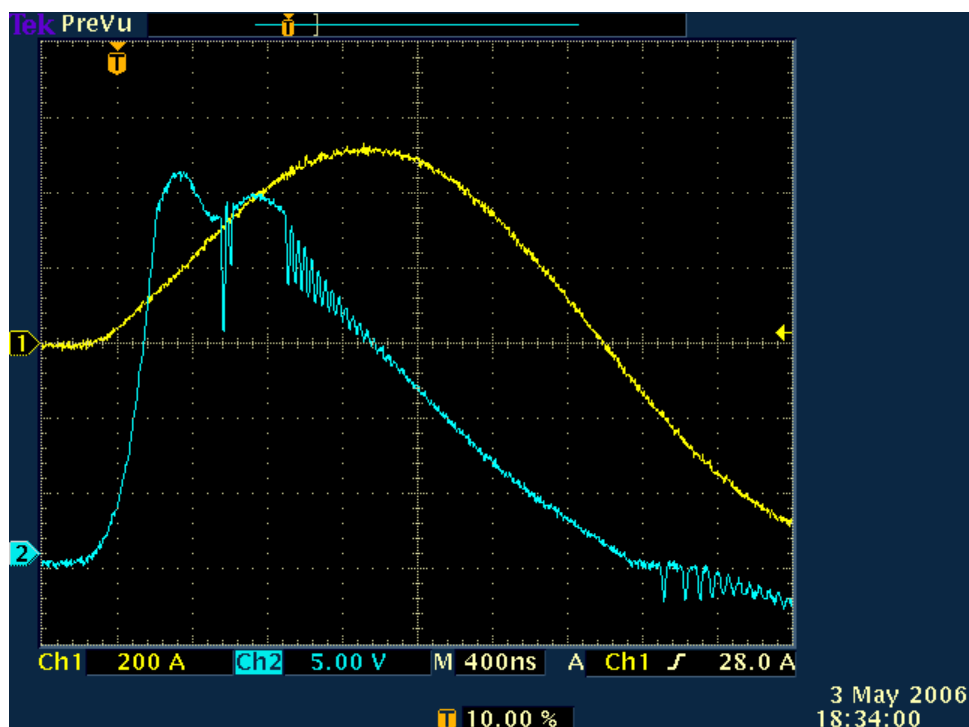
The voltage across the transistor and 100nF capacitor was measured.

The transorb and capacitor voltage are hitting the 24 volt limit much as expected. there would appear to be sufficient voltage to continue charging the IGBT gate. However, the capacitor voltage is also being driven down instead of remaining steady near the 24 volt level.

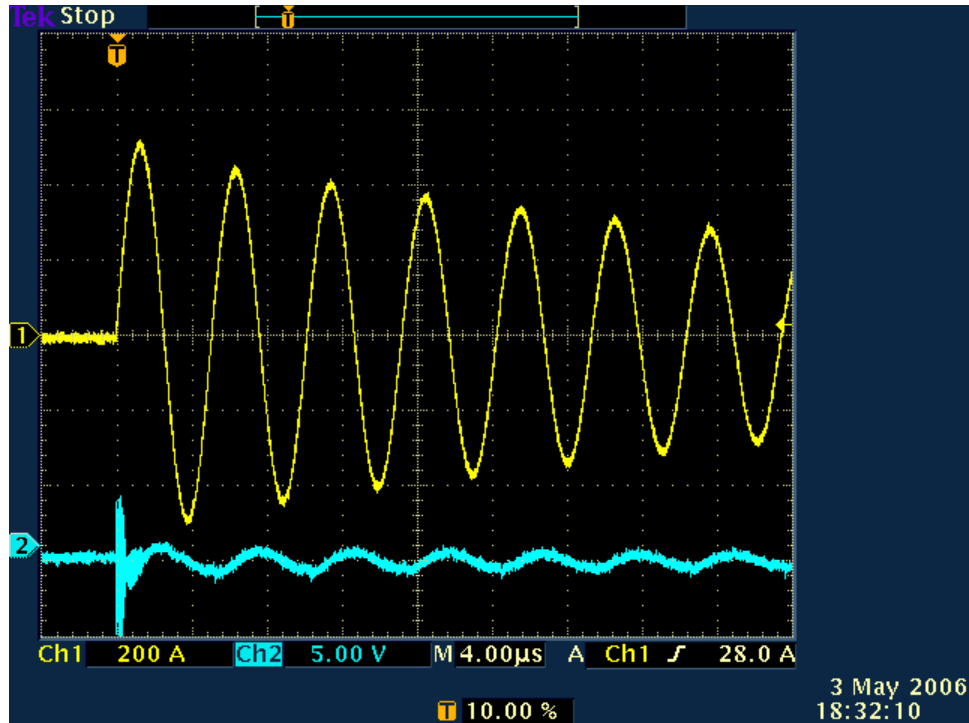
As a comparison, the gap was directly shorted with a heavy wire at 300V.

The loss is somewhat less as seen by the longer ring down time but that is expected at low power. There may be noise being picked up on the voltage probe that might have some effect on the readings. The scope and voltage probe electronics were moved further back.

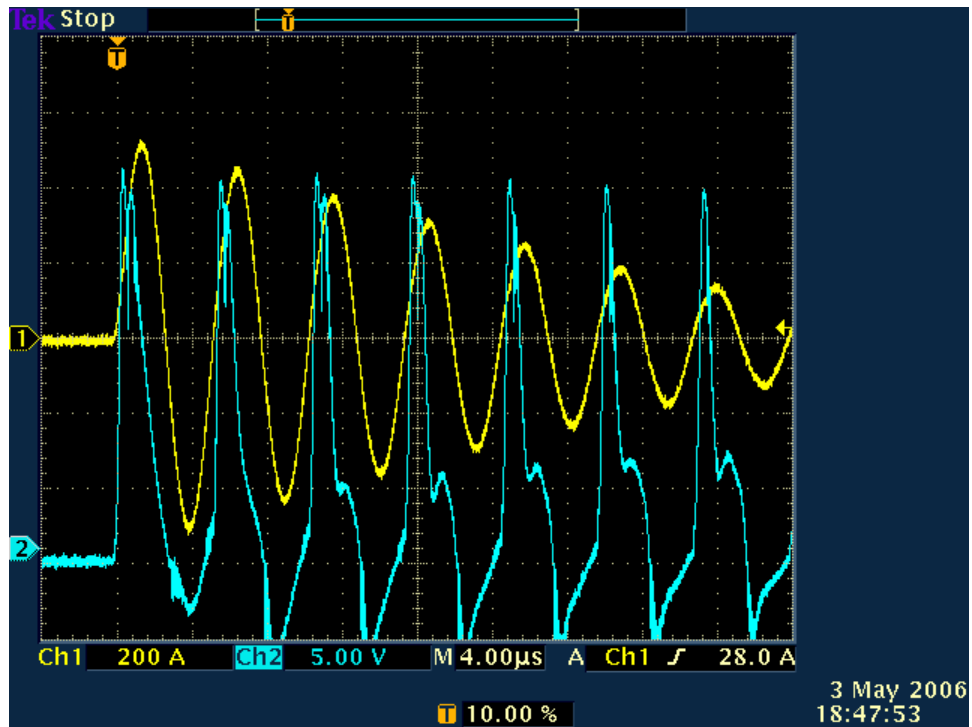
Moving the test equipment further back seem to have no effect on the readings.

It's all probably real...
